Narragansett Historic District Commission

Historic Preservation Standards and Guidelines

October 4, 2010

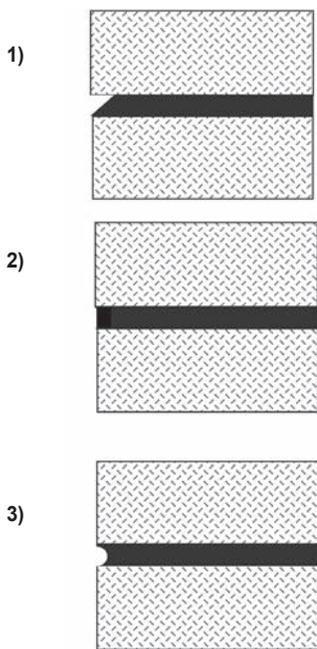
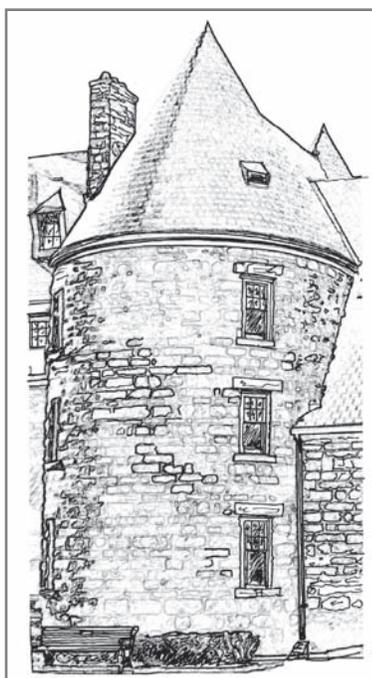
MORTAR JOINTS

- 1) Struck with drip
- 2) Flush
- 3) Tooled
- 4) Beaded (raised)

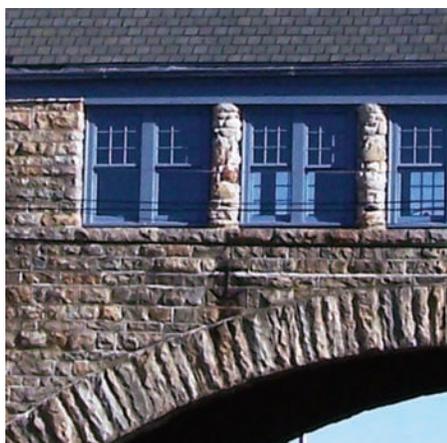
Rough-surfaced masonry provides architectural character

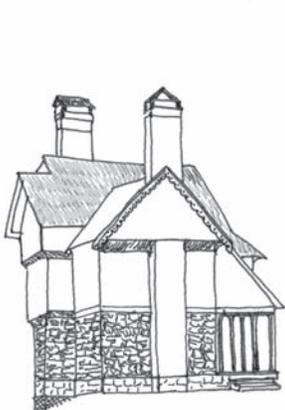
Simple Colonial roof

Complex Victorian roof

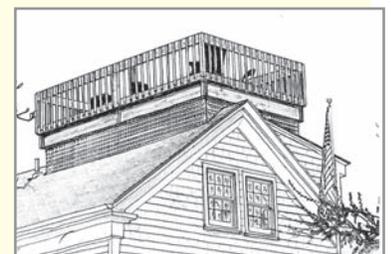
Not appropriate roof decks and set-in roof balcony (left)

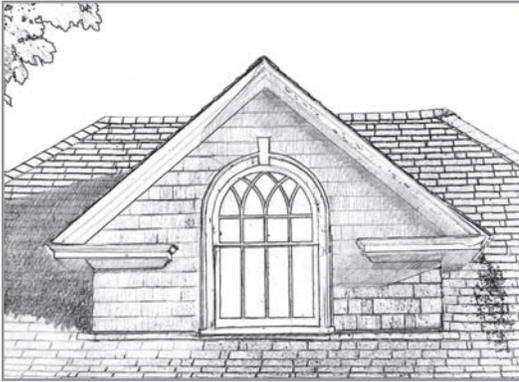
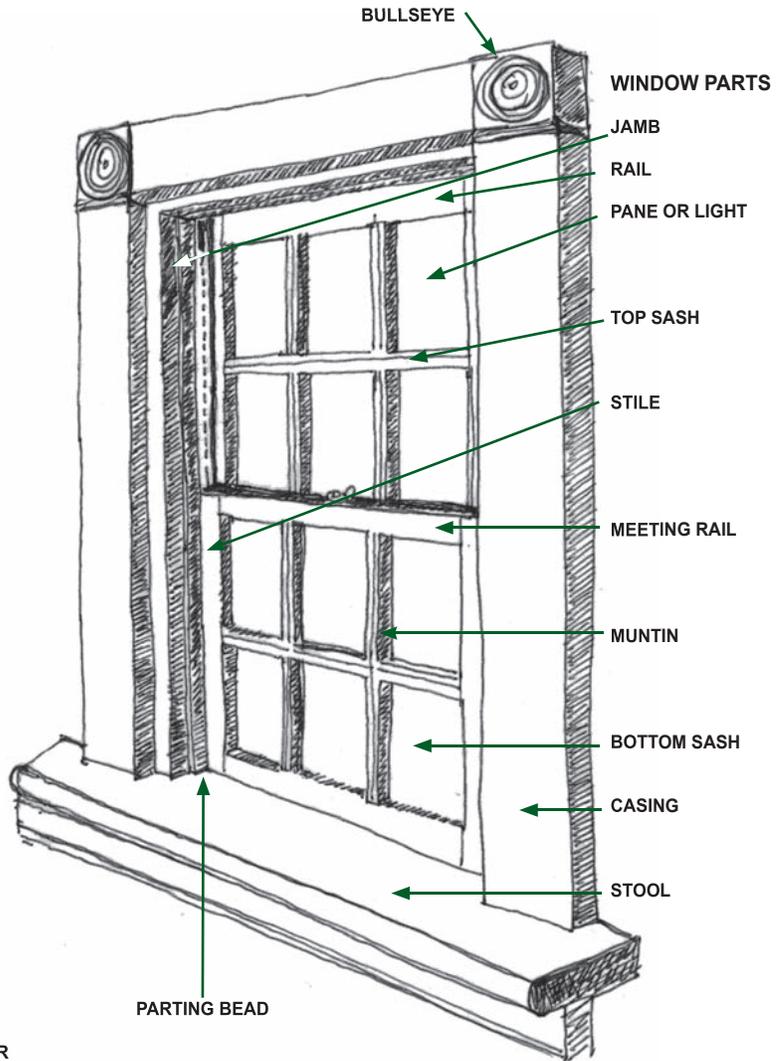
DOUBLE-HUNG WINDOW PARTS

Appropriate window: Colonial Revival

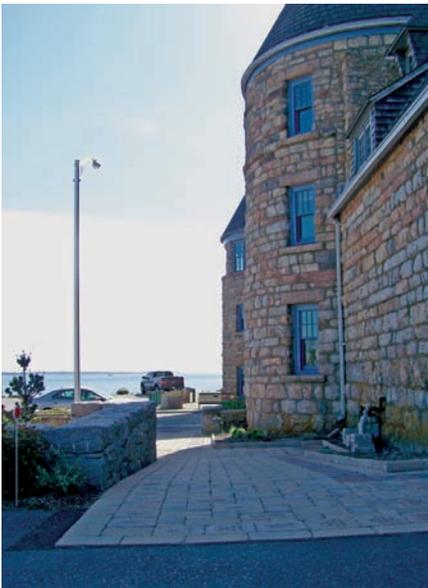
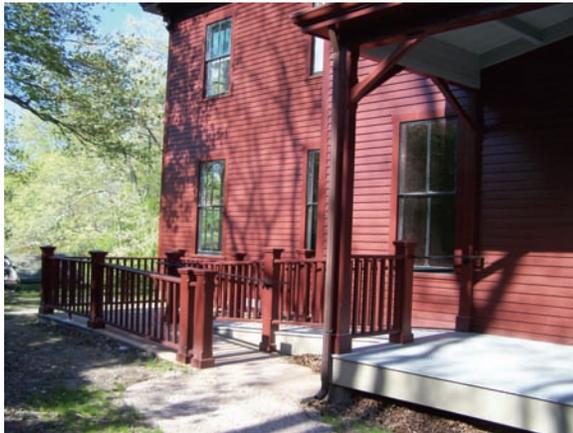
RAMPS

Left—Appropriate, ramp created by grading

Top—Appropriate, ramp on side, railing blends with building, regrading minimizes length
