2017 Middlebridge Conservation Land Management Plan

The Middlebridge Conservation Land is a 9.51-acre river front recreational area located directly on the Narrow River in the Town of Narragansett. The acquisition and protection of this unique property provides the Town of Narragansett an opportunity to provide residents access for kayaking, fishing, marine activities along with wildlife viewing and interpretation for future generations. The Middlebridge Property presently supports a kayak and paddle board concession, 37- slip marina, one caretaker's residence and two year-round residential rental units. Established by the Town Council on September 17, 2012 as an enterprise fund, it is the goal of the Town of Narragansett to provide residents an opportunity to access this important recreational and environmentally sensitive site while providing a sustaining funding source for the future.

Initial Building Assessment

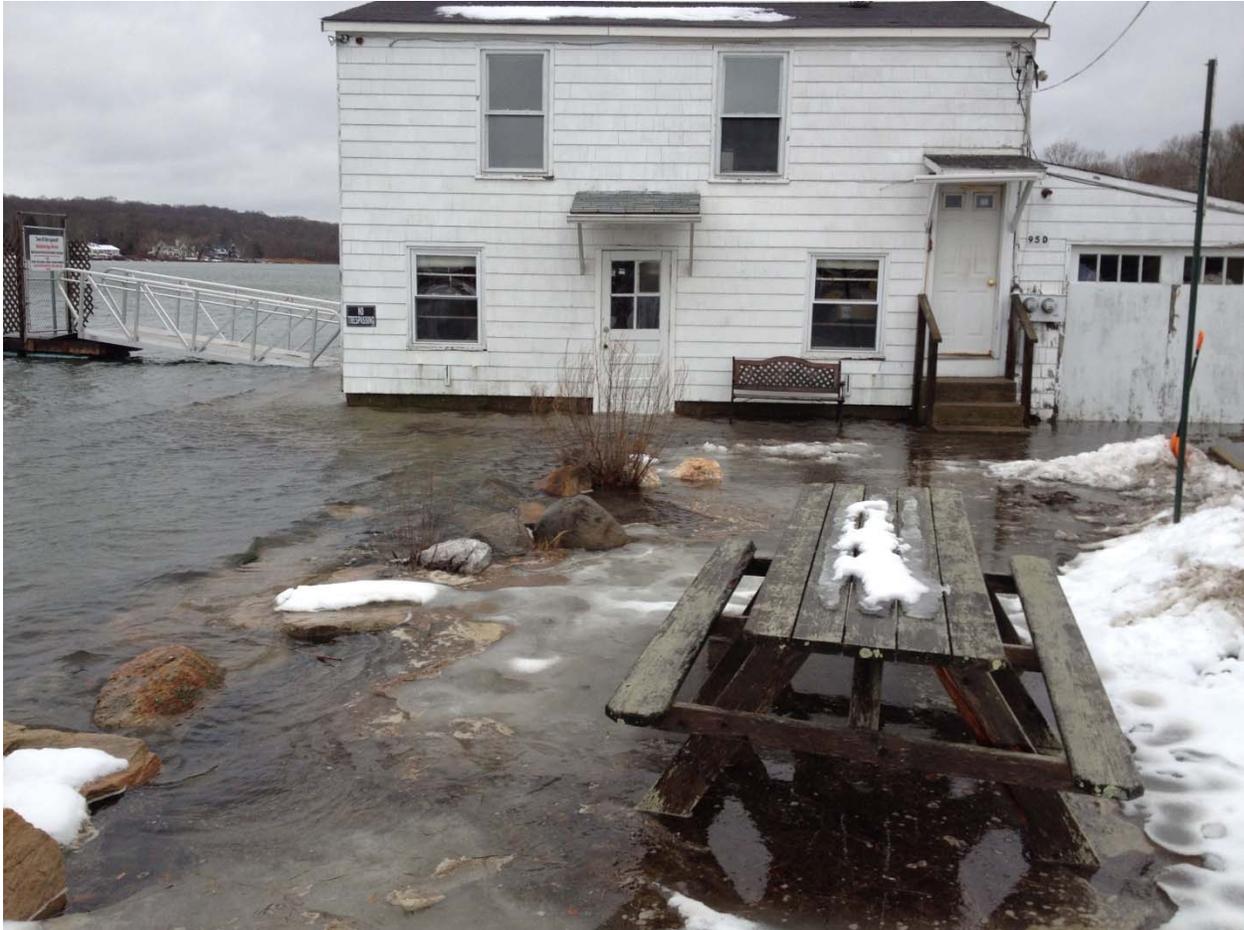
Middlebridge 95D February 14, 2014 8:00 am High Tide

- **Building 95D** - This building is commonly referred to as the “marina building.” The first floor of the Marina Building is used for storage. When the Town purchased the property, historic evidence of flooding was present, and the former owner acknowledged that at moon high tide and during major storms, the first-floor floods. Such flooding has been observed during moon high tides as in the photo, below. The furnace for this building is on the first floor and is elevated. The building continues to flood on a semi-regular basis, depending on tide and storm conditions. The second floor (Unit 95 D) had previously been used as a residential rental unit and is currently vacant. The exterior painted surfaces are peeling; as noted above. In 2012 it was determined that the building would need a new roof, shingles, windows and doors within the next five (5) to seven (7) years. The existing brick chimney appears to be in poor condition, (potentially unsafe) and unnecessary and should be removed or stabilized. The Marina Building suffered flooding damage during Hurricane Sandy. The Town did not initiate any clean-up activities at this location.

12. The following maintenance work should begin as soon as incremental budgetary funding is provided
 - a. Repaint the exterior of 95 Middlebridge ("yellow building")
 - b. Replace the roof of 95 D ("marina")
 - c. Repaint the exterior of 95 D
13. 95 Middlebridge ("yellow building") should be developed as a visitor center or meeting room
 - a. 2nd floor should be only used for storage

14. 95 D Middlebridge (“marina”)
 - a. 1st floor should continue to be site storage for the marina, marine recreation concession, and URI rowing team
 - b. 2nd floor should be used by the URI Women’s Rowing team for storage

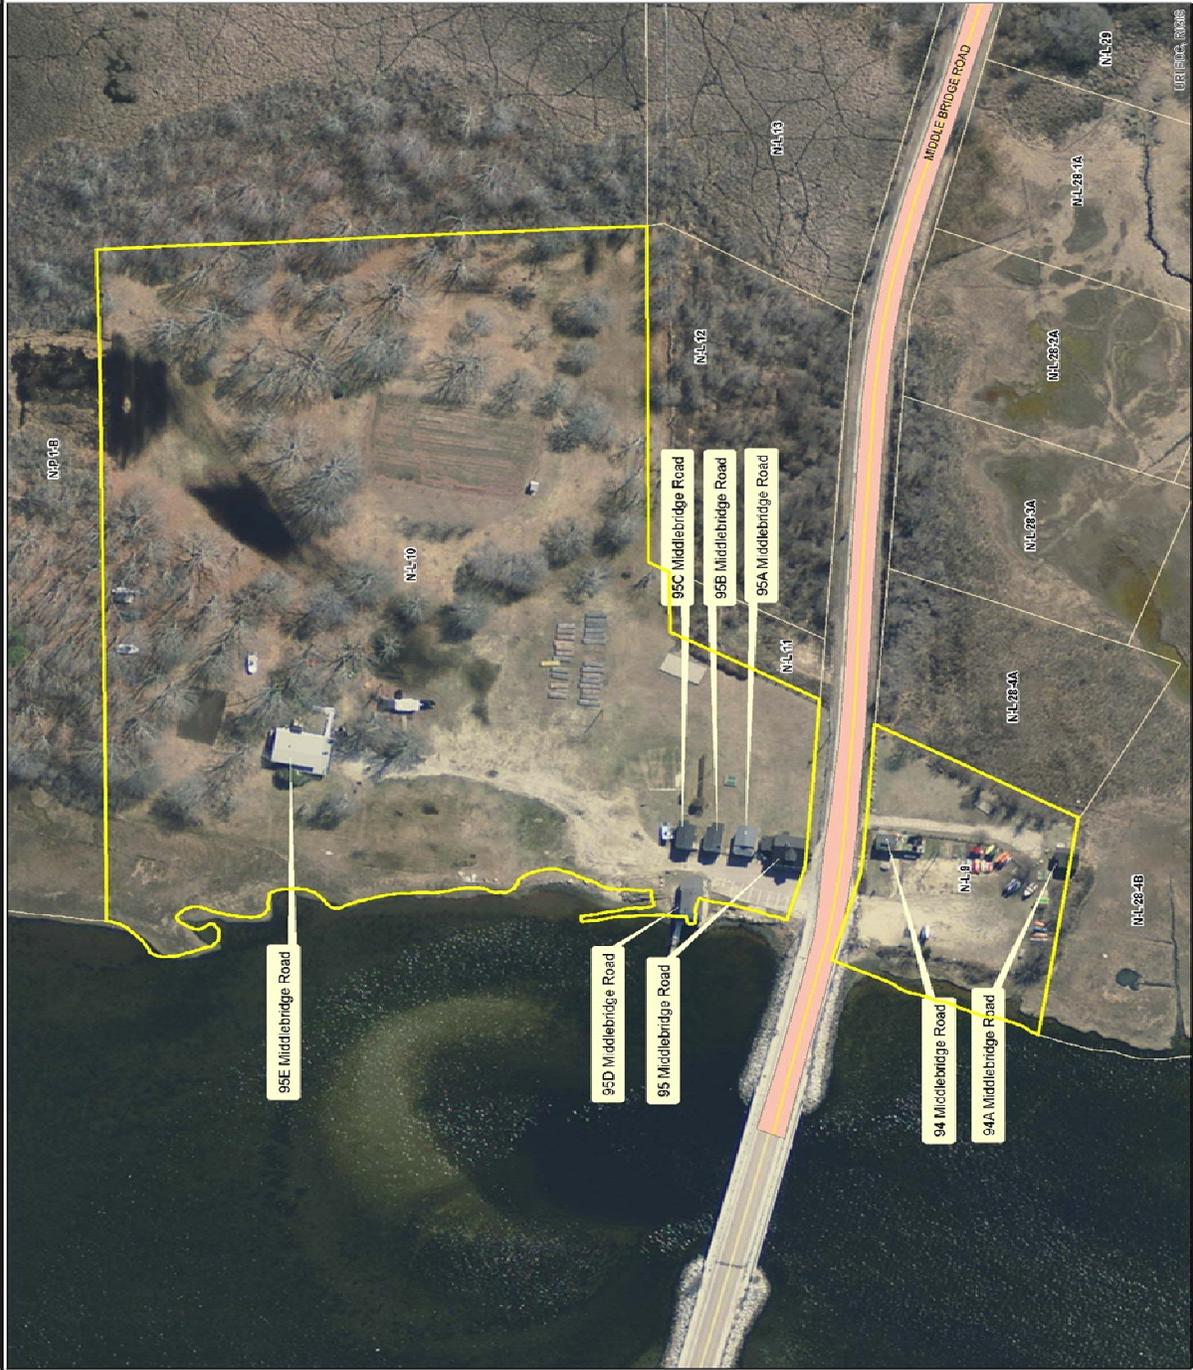
Map A – Middlebridge Conservation Land Site Map showing buildings

The site (including both parcels) includes active residential and commercial uses, as well as partially-maintained open space. The Department of Community Development has segmented the property into the following use categories. Please refer to Map A and B.

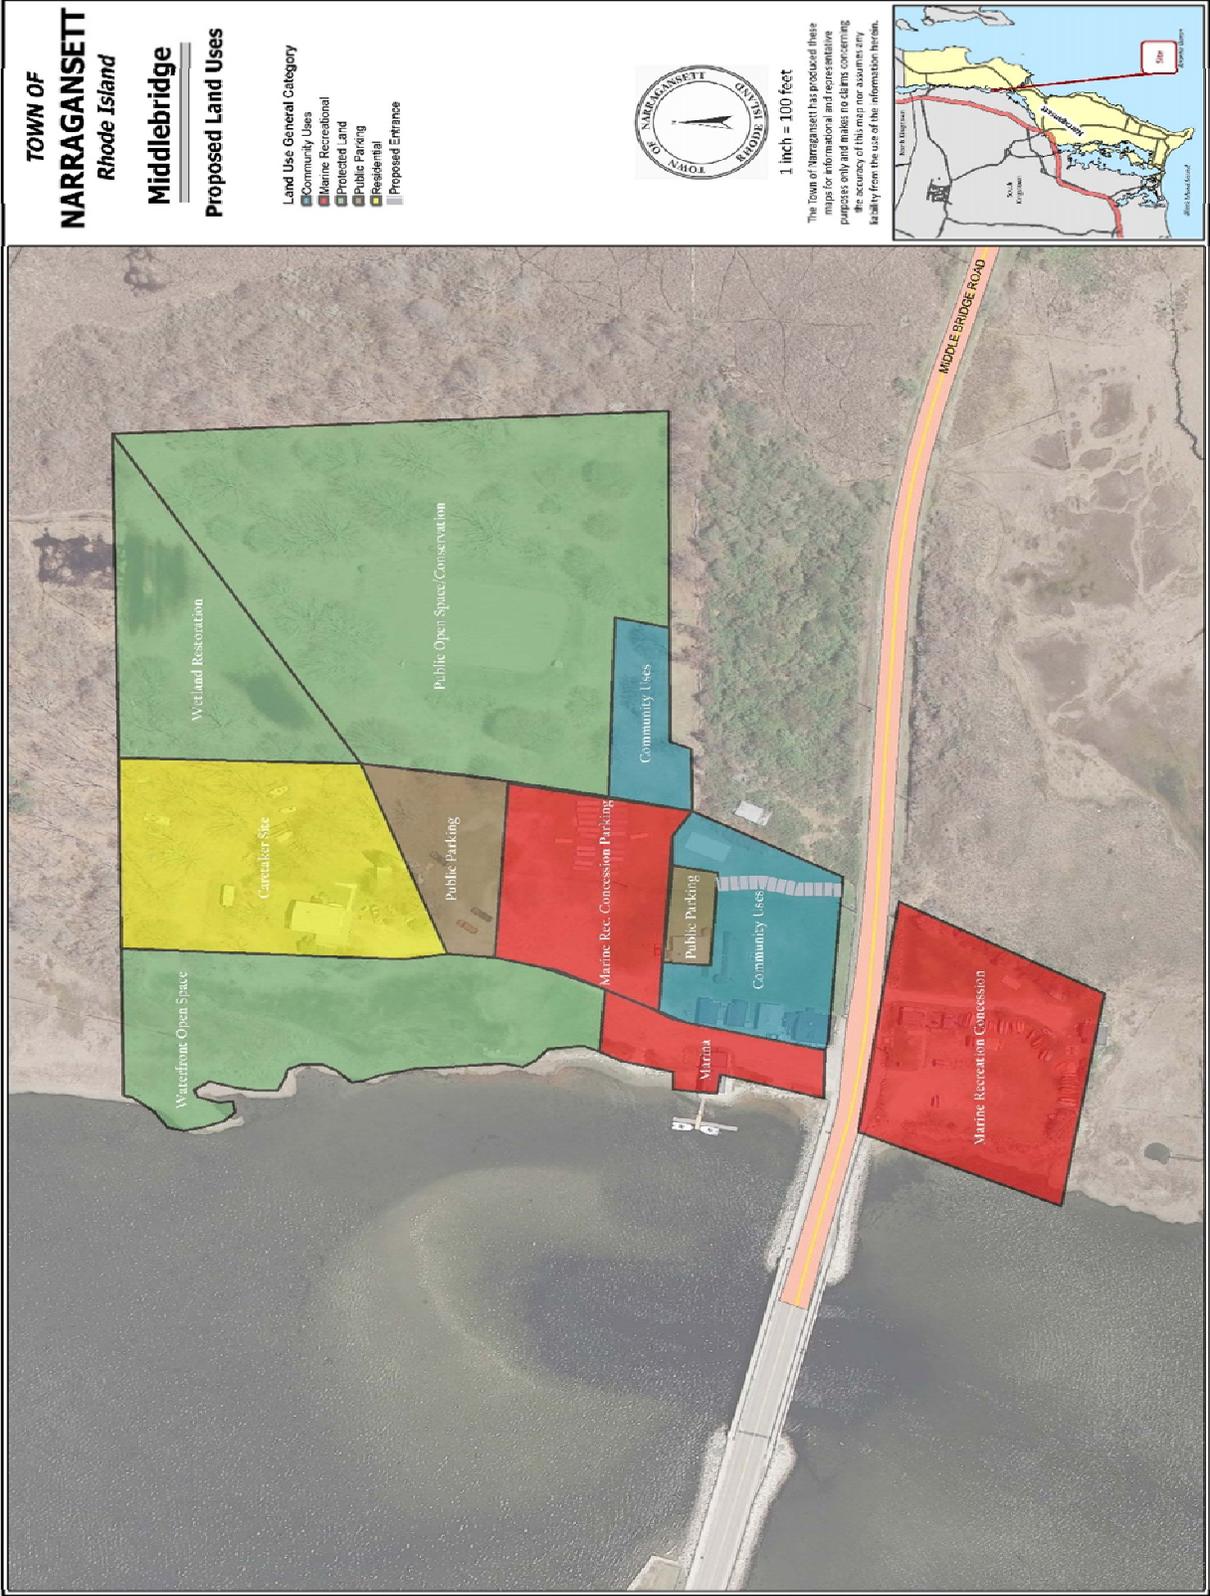
Map B – Middlebridge Conservation Land Site Map showing land use categories

The following sections summarize the recommendations of the Trust to the Town Council, by segment of the property and are referenced on Map B.
